Final Report

Leigh River sediment sourcing and transport

Job 6003051

Corangamite Catchment Management Authority

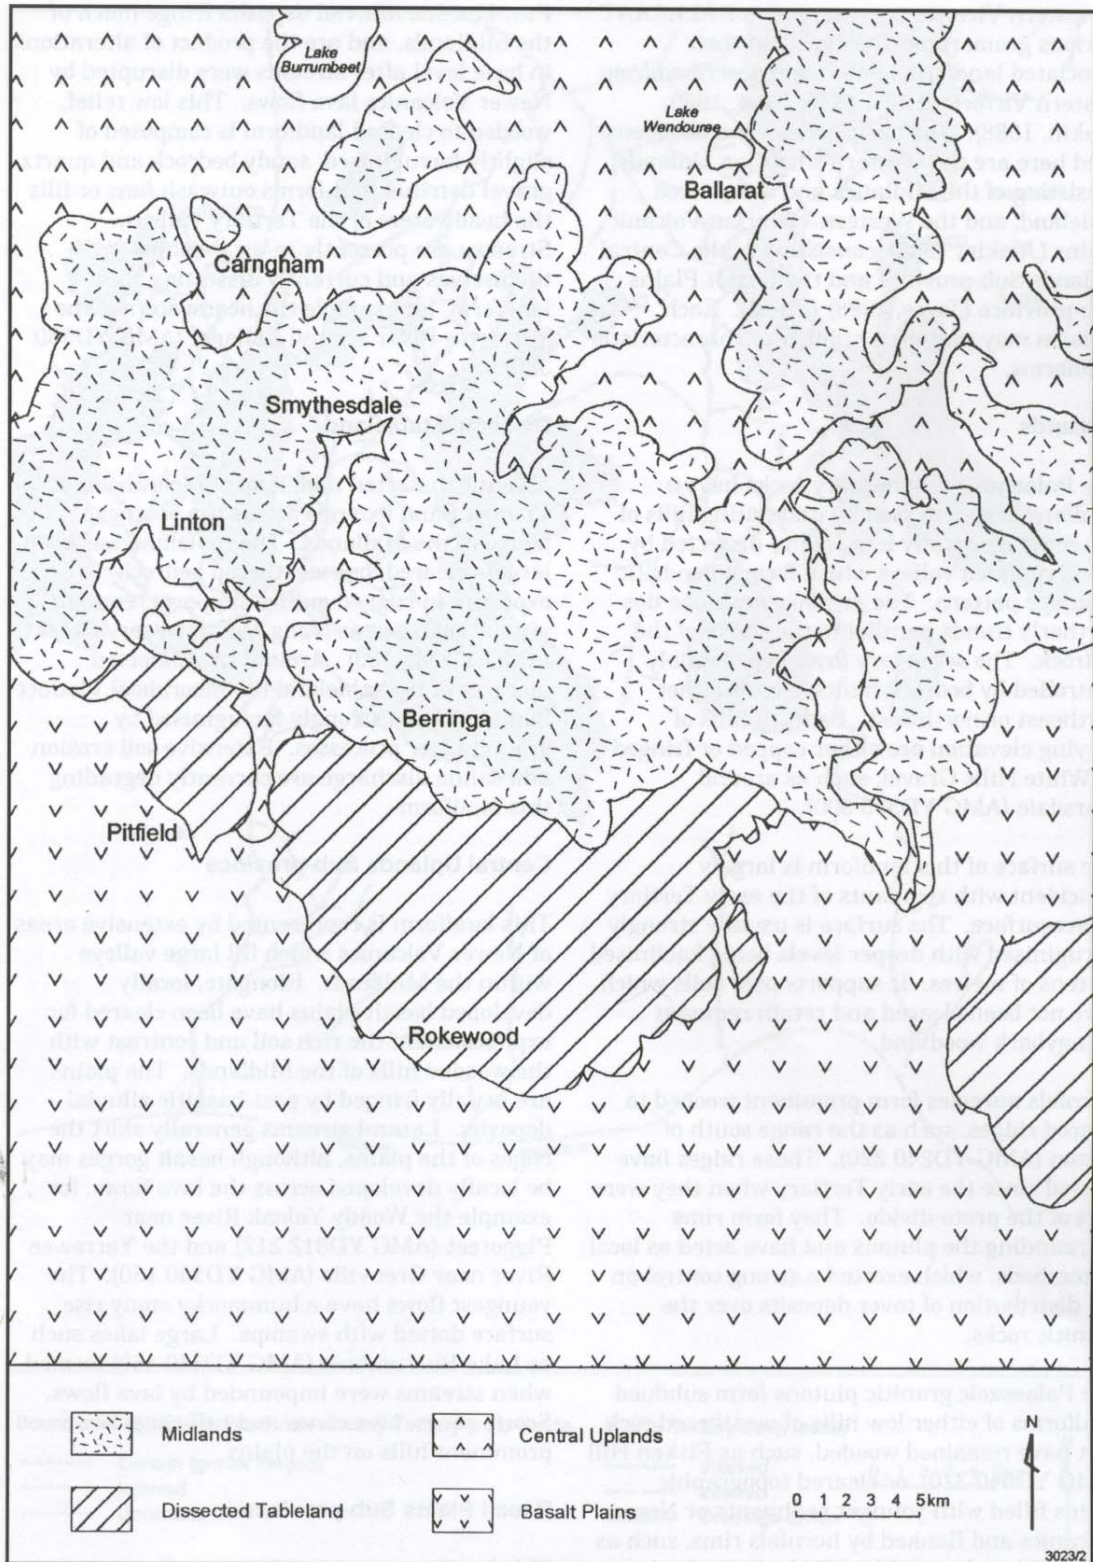
Figure 1 Geomorphic divisions on the Ballarat 1:100,000 map sheet. The Leigh Catchment is on the right of the mapped area, and extends as far south as the Shelford area.

There are four main landforms in the Leigh Catchment (Figure 1).

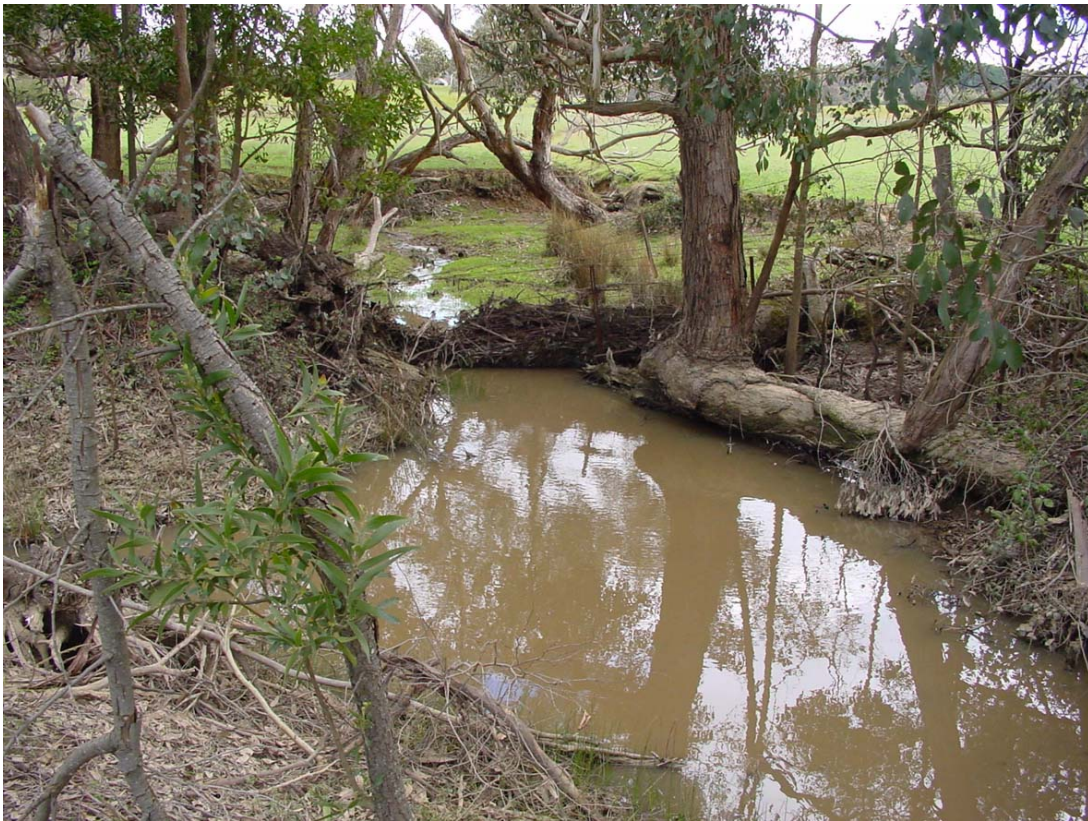
Figure 2 Headcut at 0751958 5822987, looking up the valley onto the intact fill surface. The recently formed channel immediately downstream of the road bridge at this location 1.5 km west of Durham Lead is around 1.5 m deep and several metres wide. This process is generating considerable volumes of sediment, which will be transported downstream. Flow is from left to right. The scarp visible behind the trees is approximately 70 cm high.

The cut phase takes place when a headcut or knickpoint retreats up through the swamp, eroding a channel. This process is analogous to gullying, but can occur on a much larger scale potentially releasing large volumes of sediment into the resultant stream. Active headcuts were observed in the western part of the catchment (see Figure 2).

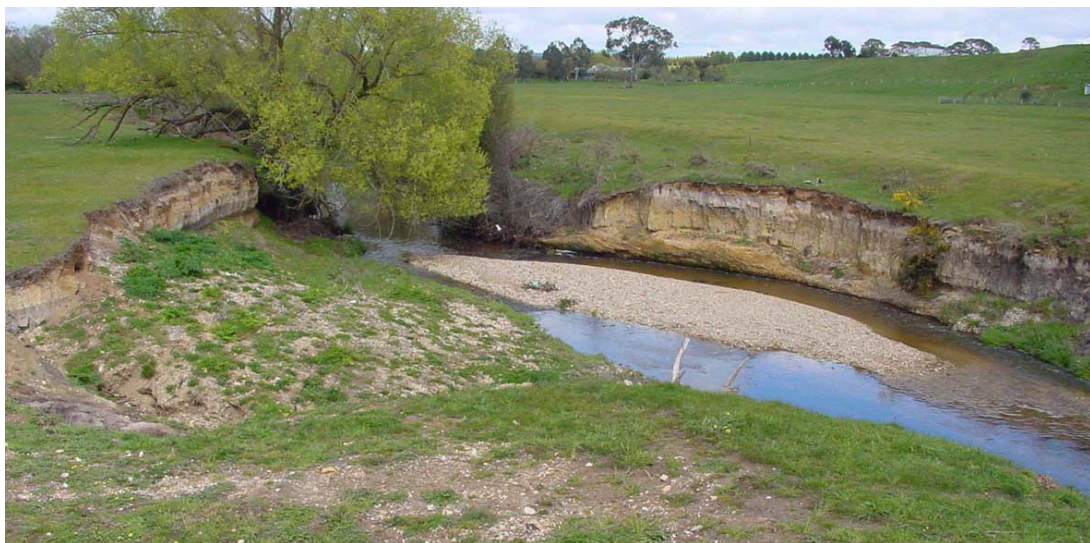
Figure 4 Looking downstream on the main channel from the one land road bridge at the very southern end of the Ballarat urban area (0750639 5832837). Bank retreat of many metres has occurred at this site and appears to be ongoing. The banks are up to 2.5 m high, and consist of around 2 m of silt and sand overlaying gravel. Bank erosion occurs as flows on the outside of minor bends encroach against the base of the bank. The gravels at the base bank are prone to erosion. With the supporting gravels cut away, the overlaying silts and sands topple in to the channel. The bar in the channel is armoured with gravel, making it a relatively stable surface and prevents the bed from degrading or lowering. Flow is from right to left.

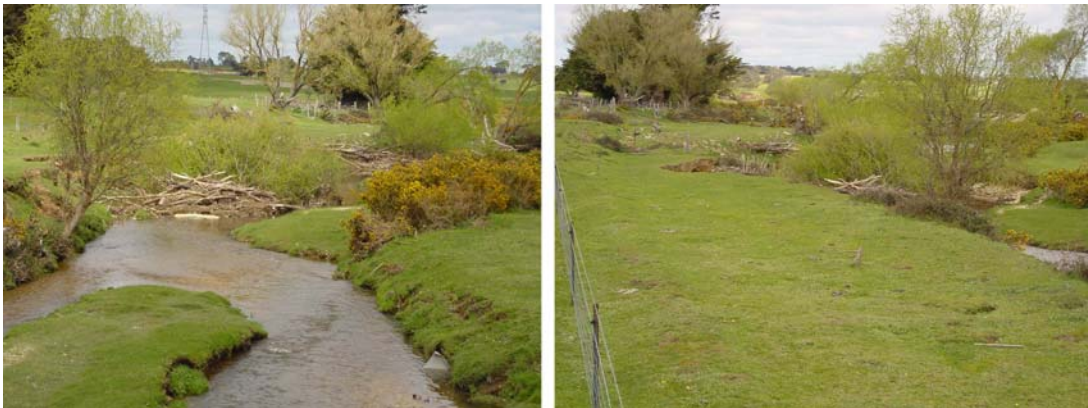
Figure 6 Large woody debris dam formed around a mid-channel willow, and associated bank erosion, in the main channel at Glassons Road (0749821 5829622). Both photos show the same jam from different angles looking downstream. The bank retreat is due to the debris dam directing flow towards the bank, where erosion up to 3 m back from the channel and up to c.10 m long has occurred. Note also the grassed mid-channel (centre foreground) and bank attached (mid-photo) bars. A revegetation strategy is underway immediately upstream of this site.

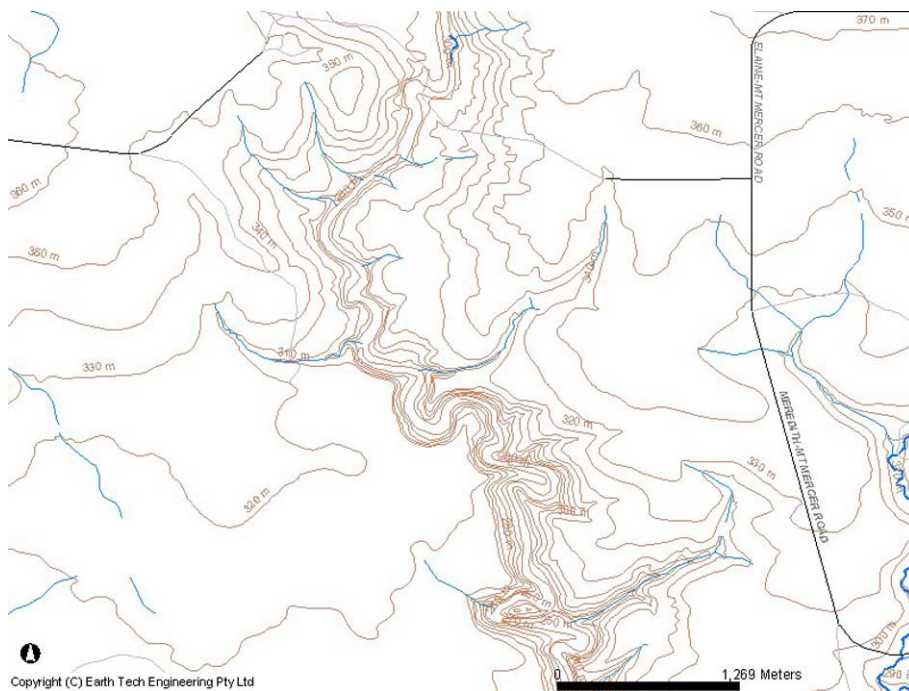
Figure 7 Topographic map of the Leigh River gorge, in the area south of the Grand Junction Bridge (circled). The river is confined within bedrock in the floor of a valley less than 50 m wide.

The gorge is an efficient conduit and transports all the sediment that enters it downstream over years to decades. Figure 7 shows the Leigh River gorge in the area of the Grand Junction Bridge. Figure 8 shows a flood event in the gorge and a point bar at a lower flow stage.

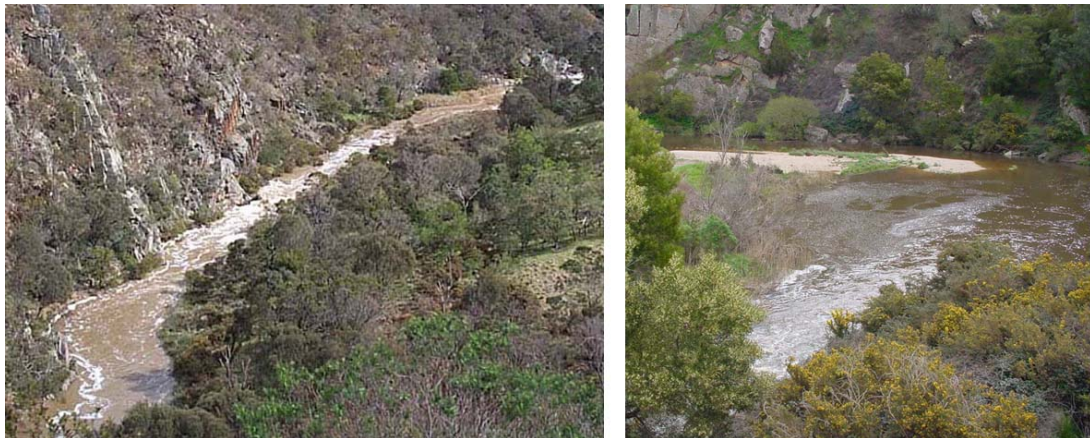
Figure 8 On the left, the gorge in Leigh River from 761772 5796393. The valley margins are often bare rock in this gorge, and the river is confined within a zone generally less than 50 m wide. Sediment accumulation is largely restricted to bars like the point bar seen in the photo on the right, taken at the bridge near Mt Mercer (756885 5810903). Such deposits would be frequently reworked by flow events such as that shown in the photo on the left, where flood waters occupy the entire width of the valley floor.

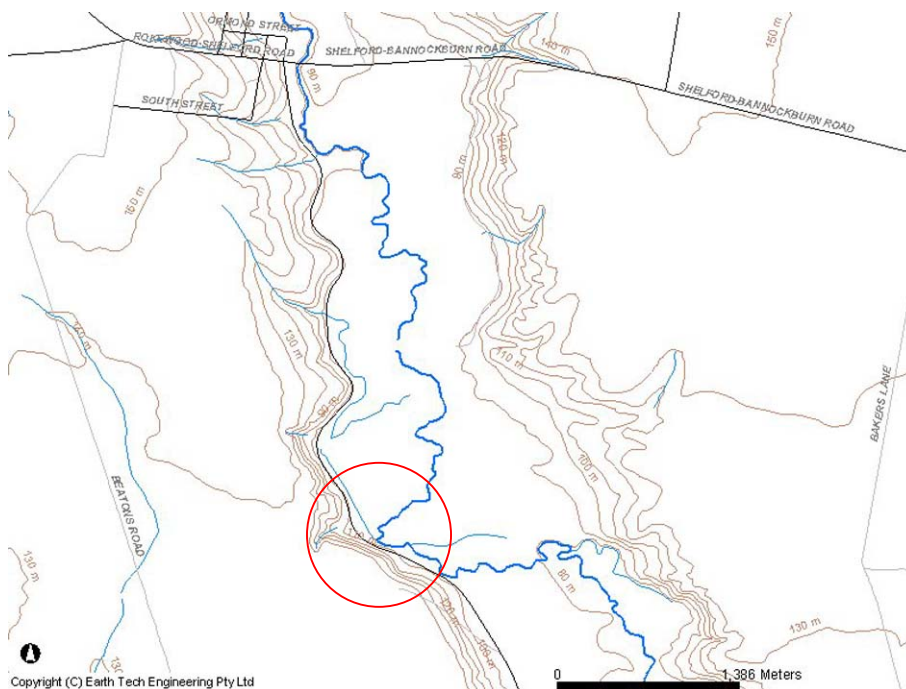
Figure 9 Topographic map of the Leigh Valley immediately downstream of Shelford. The valley is between 1 and 1.5 km wide and the channel meanders within that, only occasionally abutting the side of the valley. The circle shows the location of the photo in Figure 10.

Flow events in the spring 2003 deposited sand within the channel in this part of the river. Figure 10 shows the channel at the location circled in Figure 9. The channel bed is homogenous and flat except at tight bends where scour occurs. Habitat values are minimal in this type of sand bed stream. Minor bank erosion is being caused by stock accessing the channel.

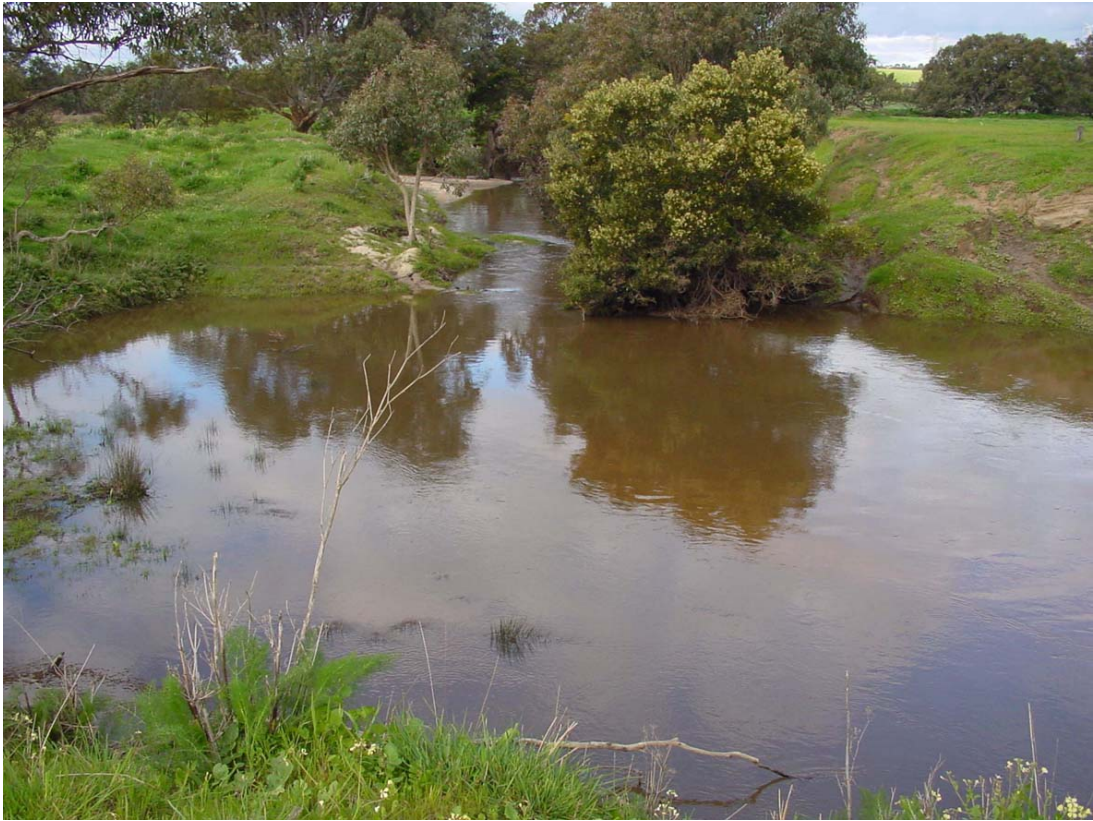
Figure 10 Looking upstream along the Leigh River at 0761598 5784618, which in Figure 3.7 is where the channel contacts the west margin of the valley around 3 km south of Shelford. Flow is toward the viewer, then swings to the right. The area to the left has been created by turbulent scour, where a portion of flow is directed upstream. The position of the channel at the point is controlled by the bedrock of the valley margin.

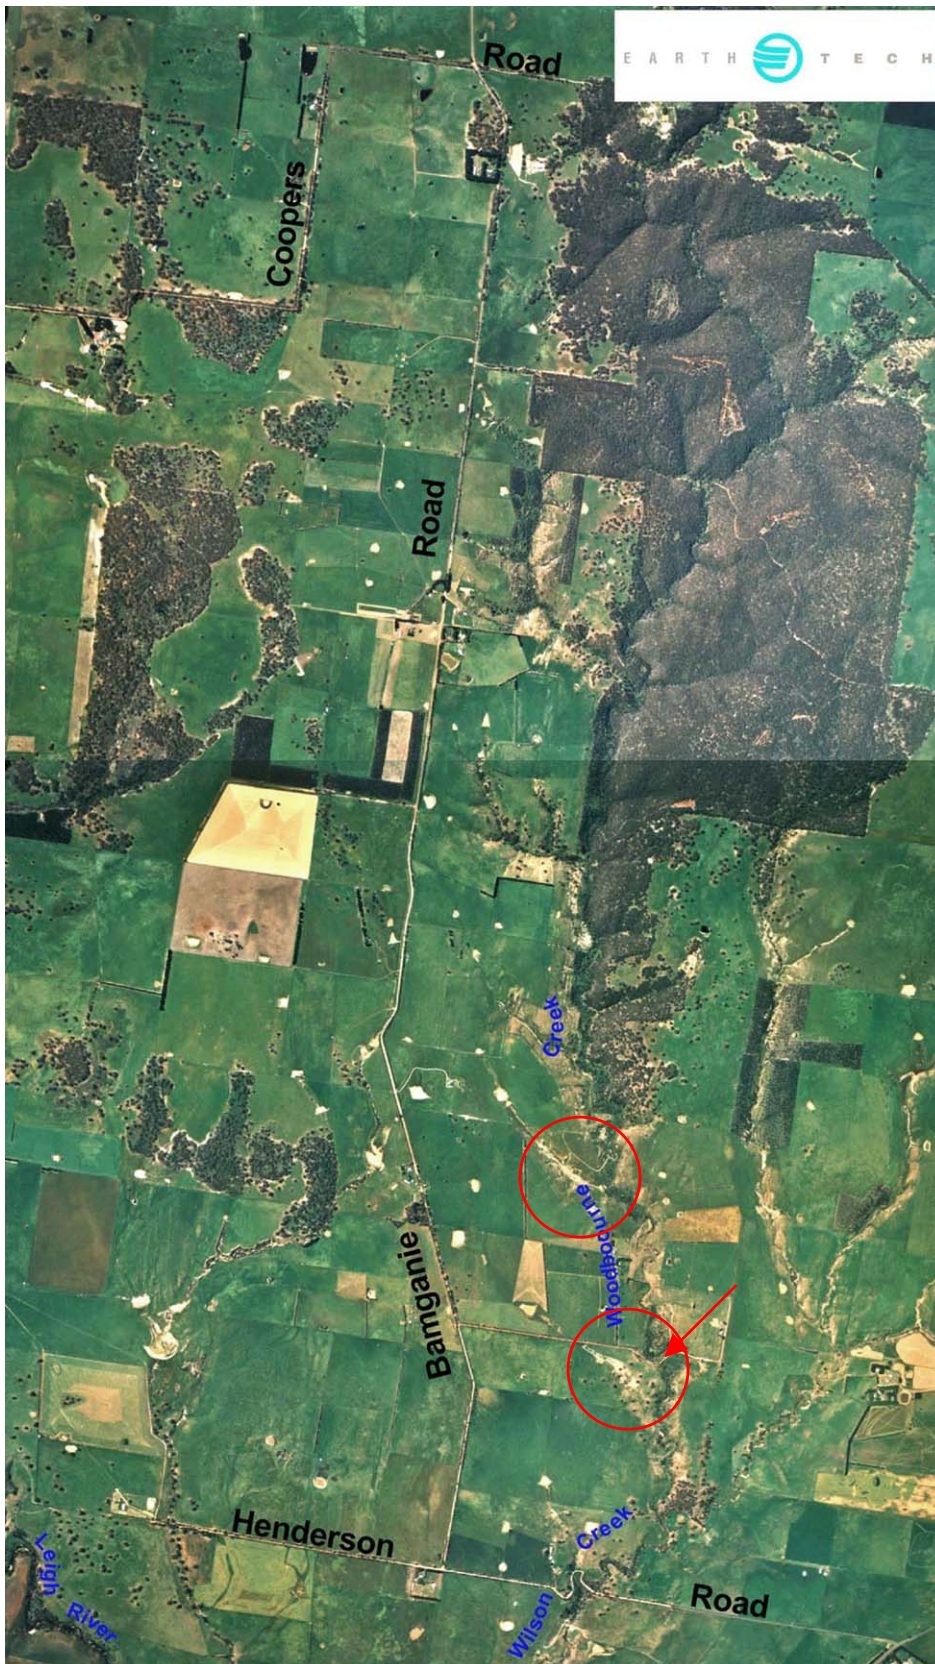
Figure 11 Aerial photograph of Woodbourne Catchment. Areas of gully erosion circled in red, arrow location of Figure 12. See text for additional details.

The 2000 aerial photos were systematically examined for evidence of widespread and/or large scale erosion, both along stream lines and on hillslopes. Hill-side gullying was observed at two locations (763300 5799000 and 763100 5800000) on Woodbourne Creek, in both cases immediately east of the Bamganie Road (circled in Figure 11). Minor slope erosion was observed along the hillsides above many streamlines in Woodbourne Catchment, but this is not on a major scale at all.

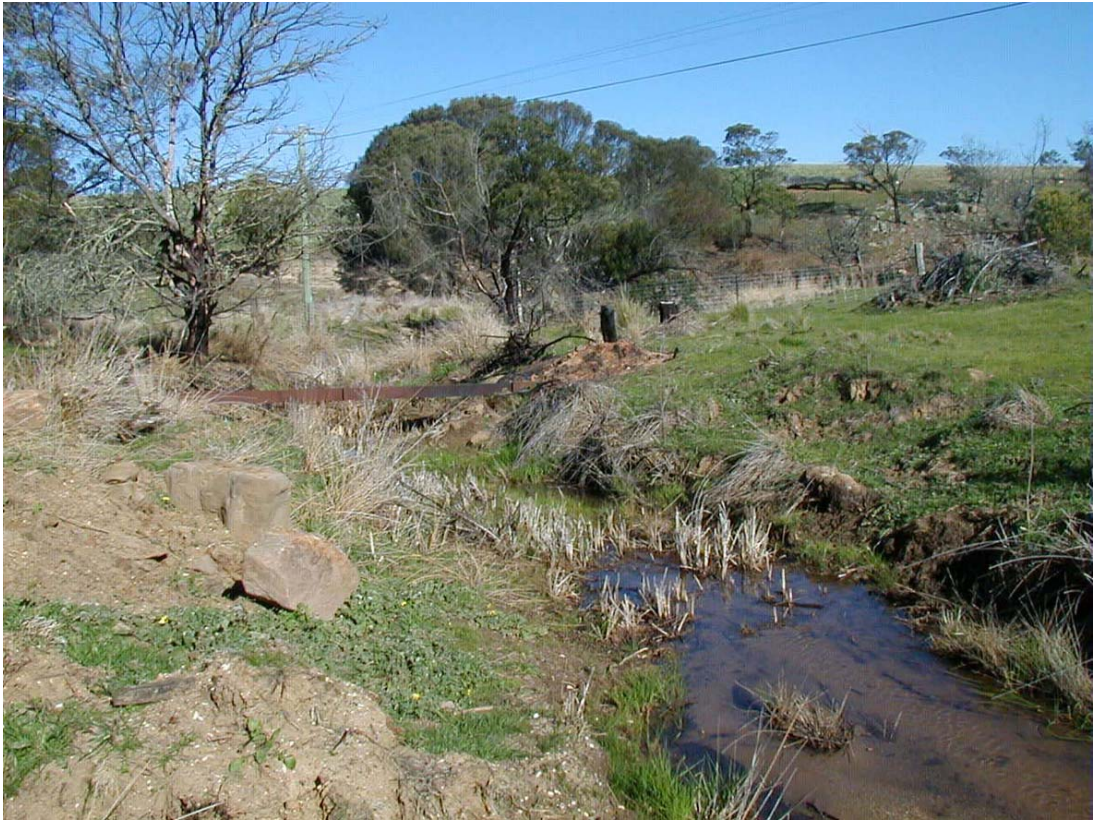
Figure 12 Woodbourne Creek east of Bamganie Road (see Figure 11. c.763650 5799100). There is no evidence of sand storage and little sand transport at this location.

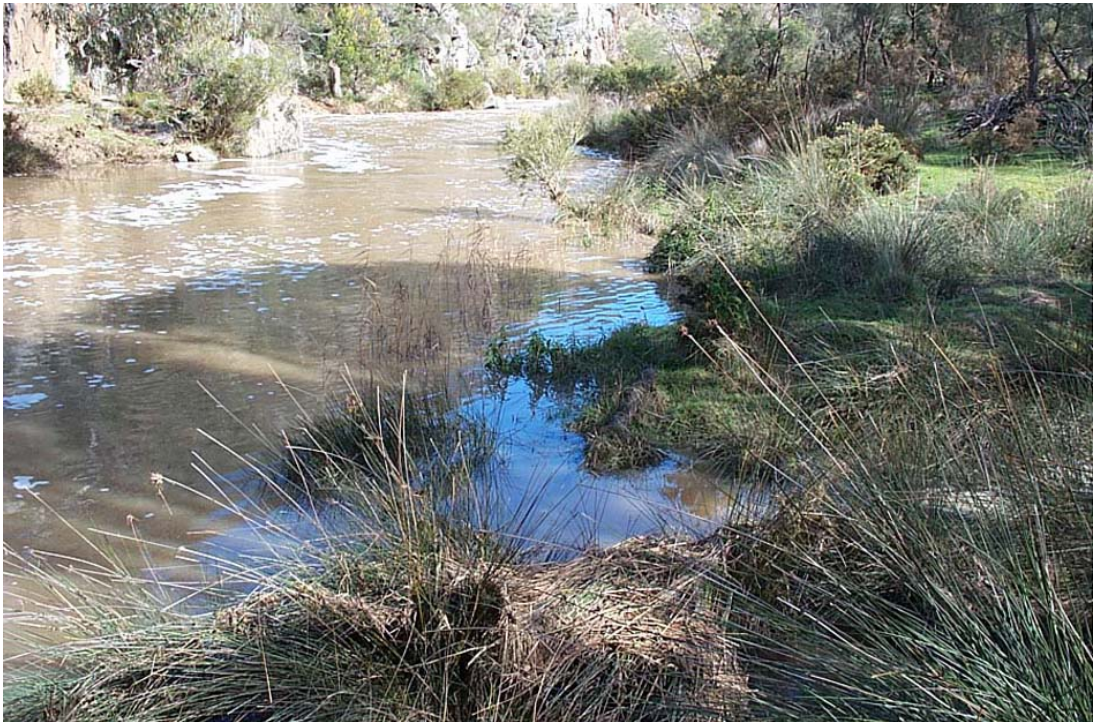
Figure 13 The confluence of Woodbourne Creek and Leigh River (main flow, towards viewer). Woodbourne Creek comes in from the right in the foreground. There is no evidence at this location of sand being supplied from Woodbourne Creek into the Leigh River channel.

Figure 13 shows the confluence of the Woodbourne Creek with the Leigh River, and there is no evidence of Woodbourne Creek transporting sand into the Leigh River. There are no significant volumes of sand stored in the bed of Woodbourne Creek at any locations that were visited on foot.

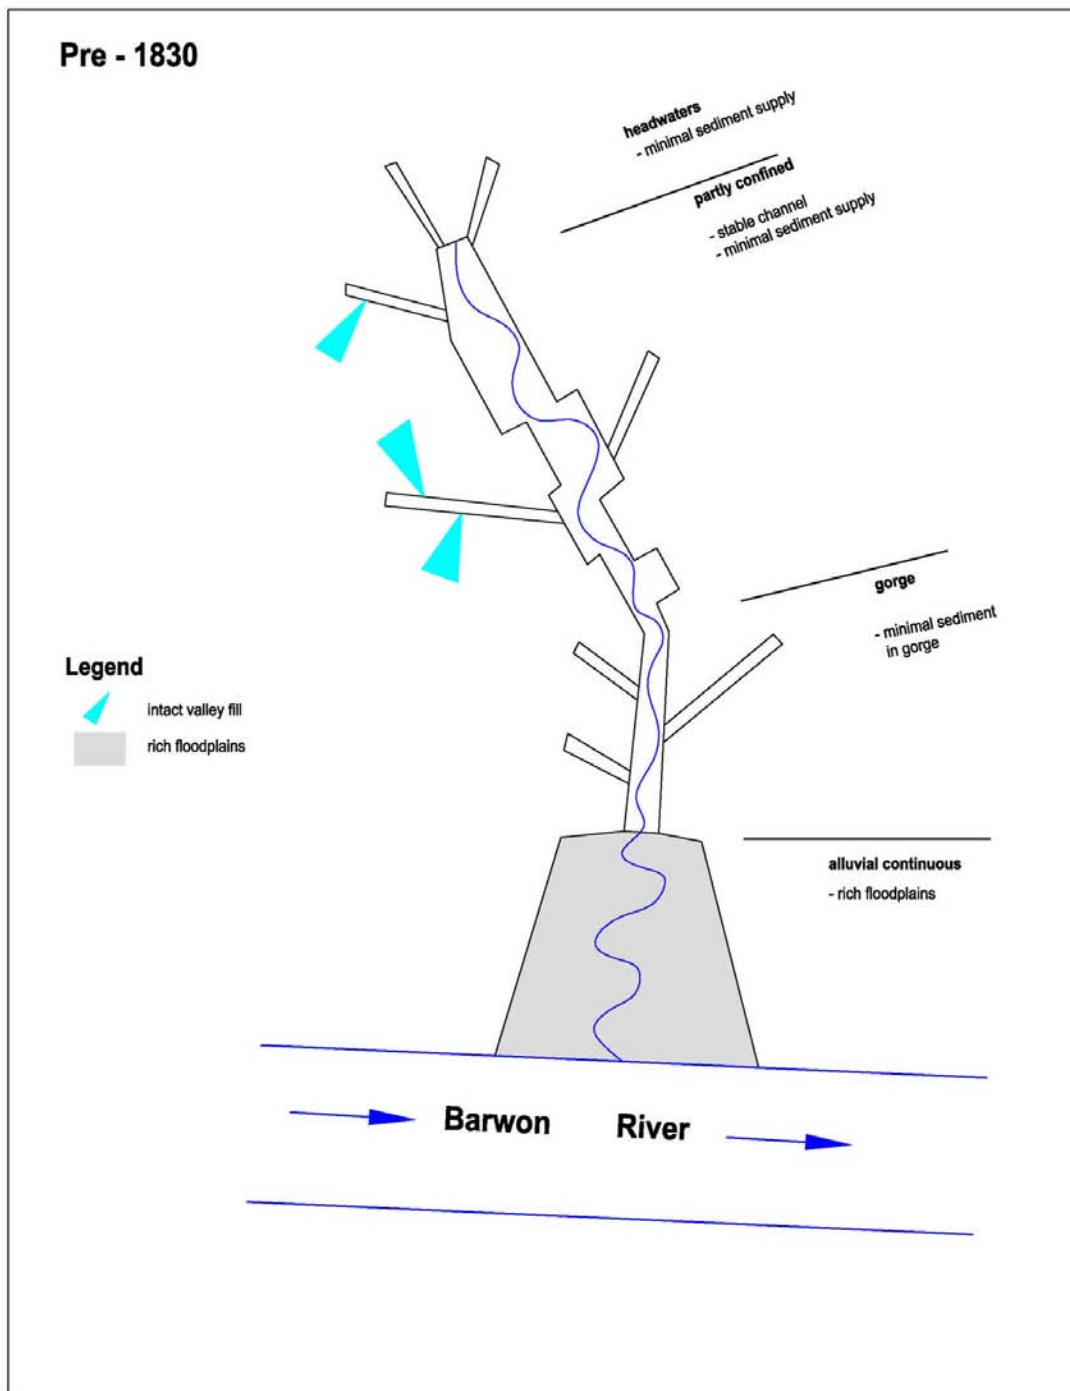
Figure 14 Schematic summary of processes in the Leigh River catchment before the arrival of European in c.1830. See text for discussion.

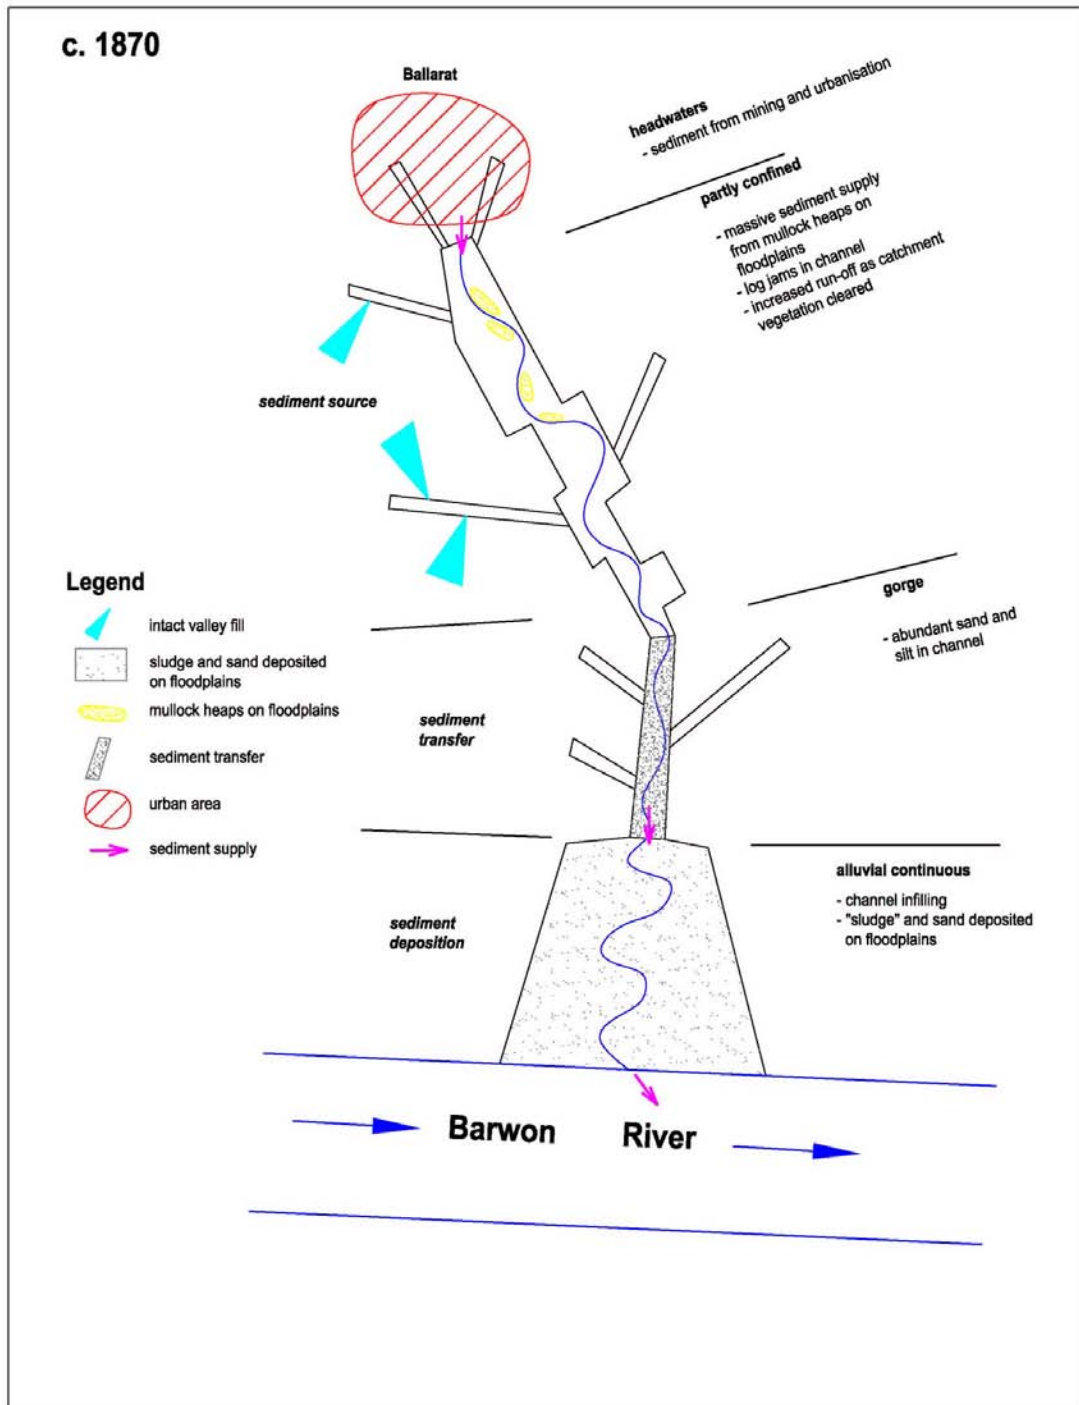
Figure 15 Schematic summary of processes in the Leigh River catchment when mining related impacts were apparent throughout the catchment, c.1870. See text for discussion.

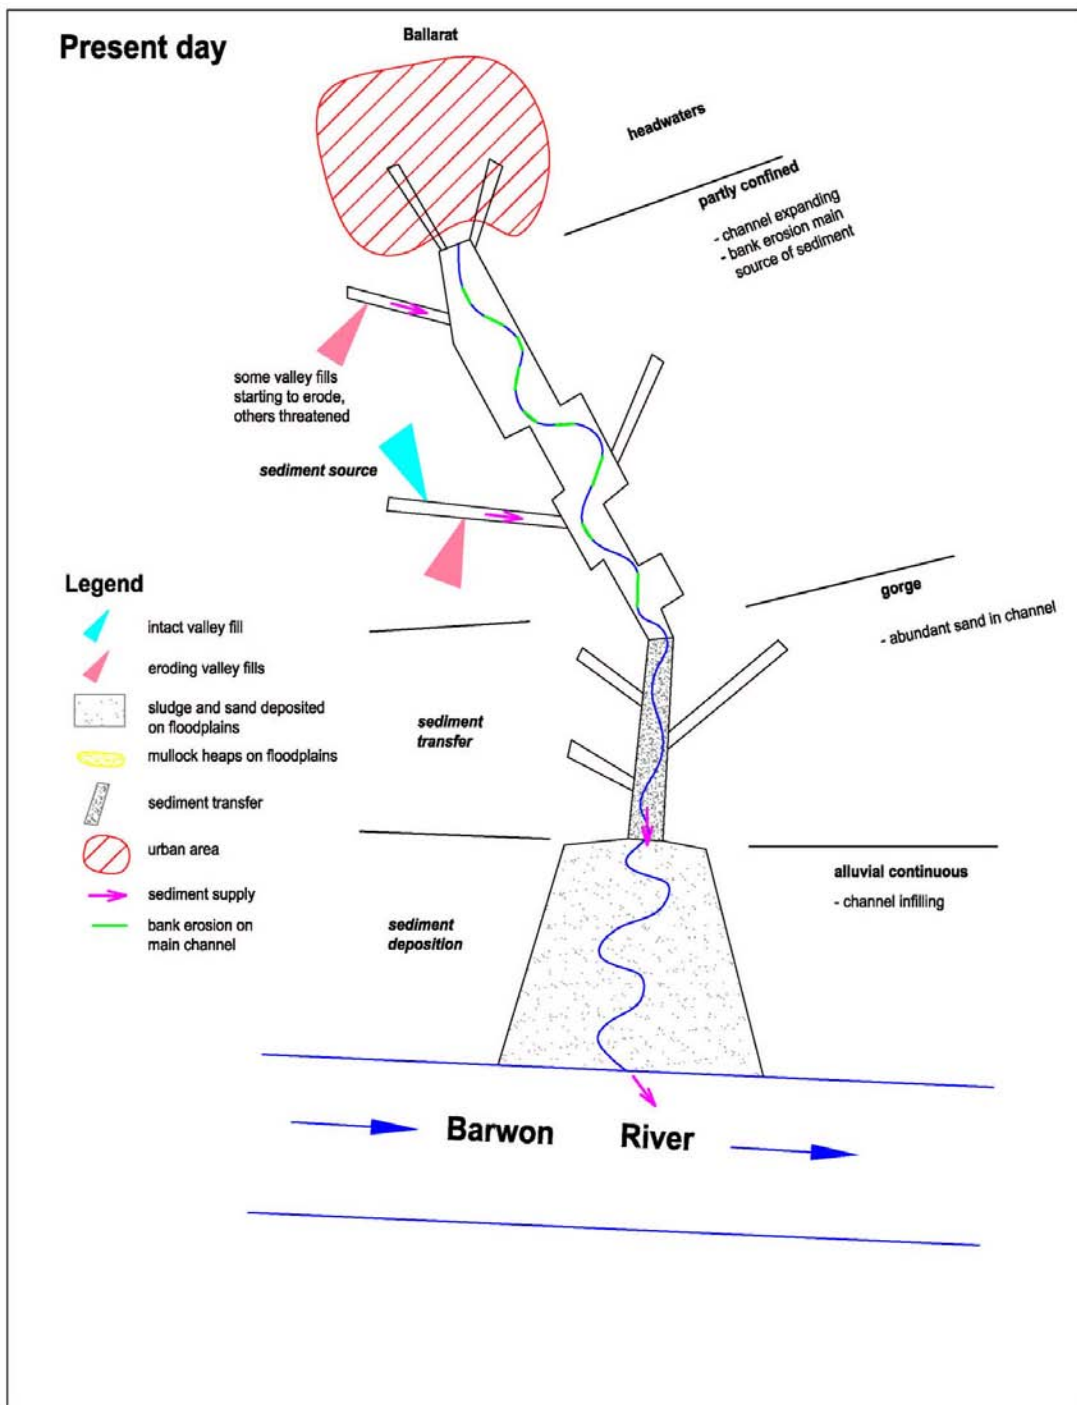
Figure 16 Schematic summary of processes in the Leigh River catchment at the present day. See text for discussion.

Mining is supplying little sediment as mullock heaps are now stable. The main channel is now expanding laterally, and bank erosion in the *source zone* is now the biggest source of sediment in the catchment (see Figure 16). Intact valley fills in the western part of the source zone are now becoming sediment sources. Knickpoints were observed to be retreating through some of valley fills, releasing sediment, and others may be under threat.
